Test report

Lindab Oy

Mechanical durability of silencer lining
during brush cleaning

Project 3470-1en

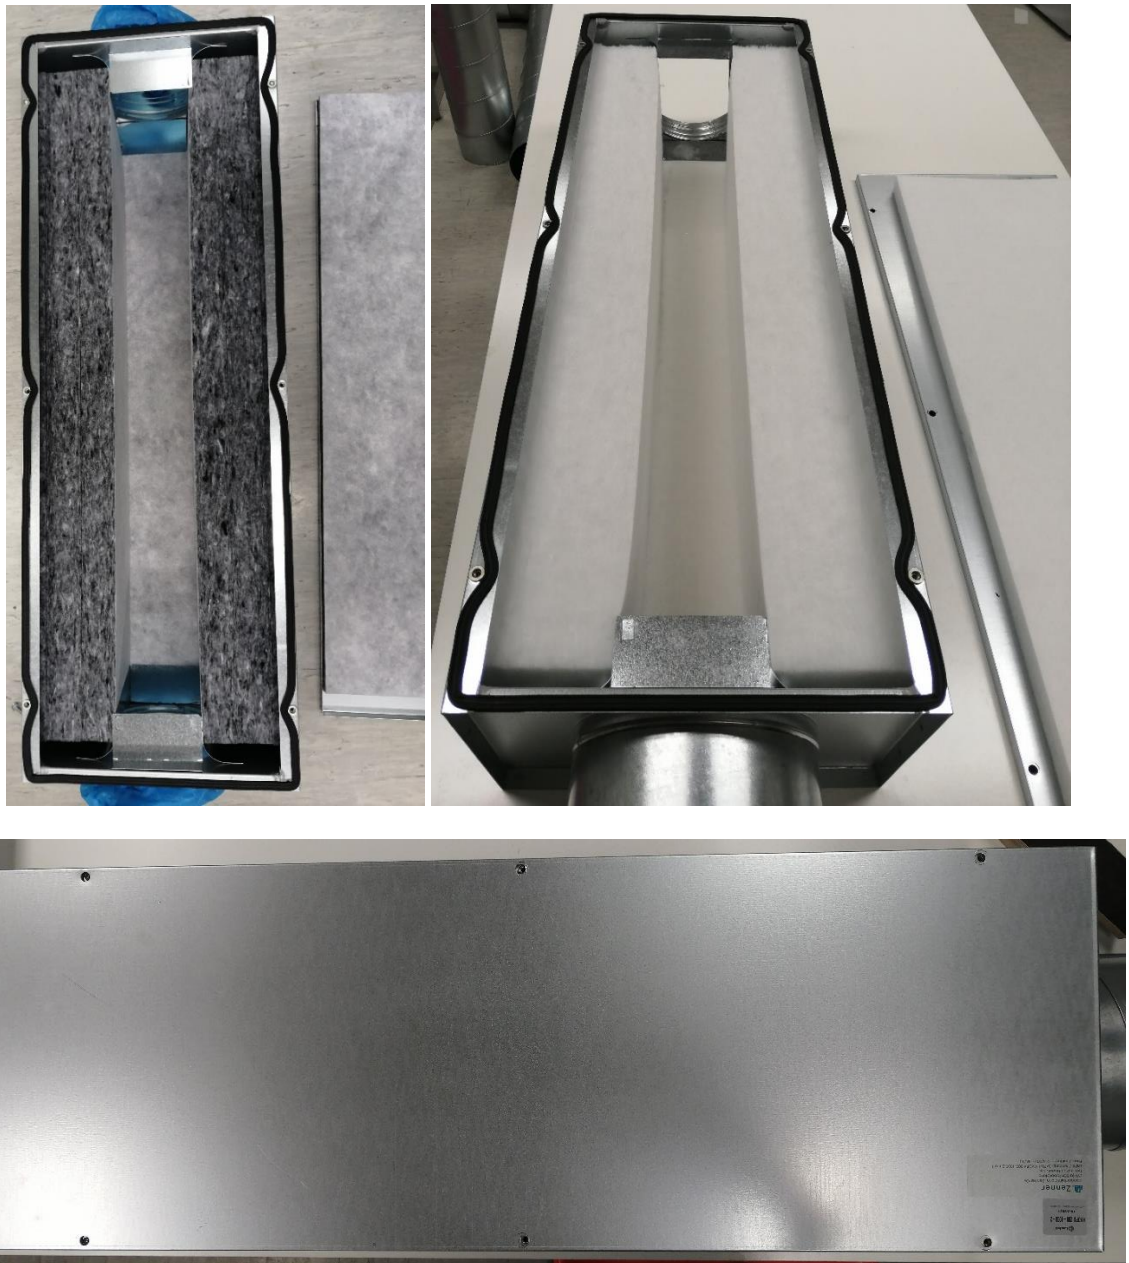
Figure 1. Measured silencers. In the top left picture model KVDPX-200-1000-2 (grey sound absorption material). In the top right picture model KVDPX-200-1000-4 (white sound absorption material). In the bottom picture a silencer with the detachable cover attached.

The examined silencers were models KVDPX-200-1000-2 (2 pcs) and KVDPX-200-1000-4 (2 pcs), delivered from the stock of Lindab Oy. Both silencers are rectangular silencers with steel casing, with a detachable cover for cleaning and inspection. Both silencers are equipped with round Ø200 duct connections. In silencer model 2, the used sound absorption material is heavy polyester fiber with a laminated fabric lining. In silencer model 4, the used sound absorption material is ordinary polyester fiber with a laminated fabric lining.

Pictures of the silencers can be seen in figure 1.

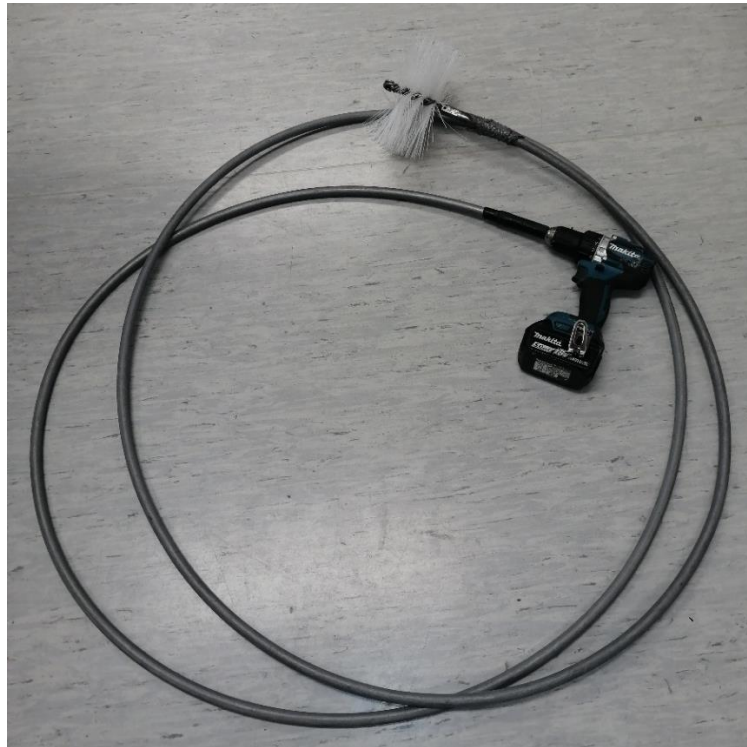
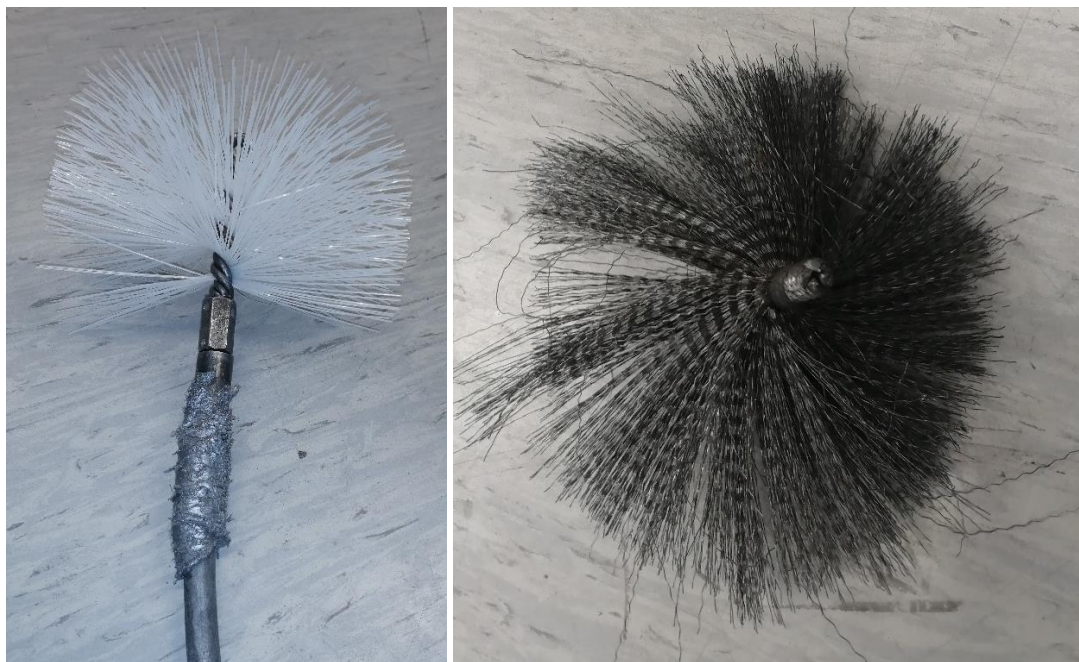
Figure 2. Brushing apparatus in the examinations. In the bottom left corner, the normally used nylon brush. In the bottom right corner, a steel brush.

The brushing was performed by an external company, IV-maailma Oy, that performs cleaning of ventilation systems. As a cleaning device, a brand-new nylon brush with an extendable shaft was used. The brush was rotated by means of a battery powered drill (Makita). The battery of the drill was changed regularly, so the rotating speed of the brush would remain constant.

Pictures of the used brushing apparatus can be seen in figure 2.

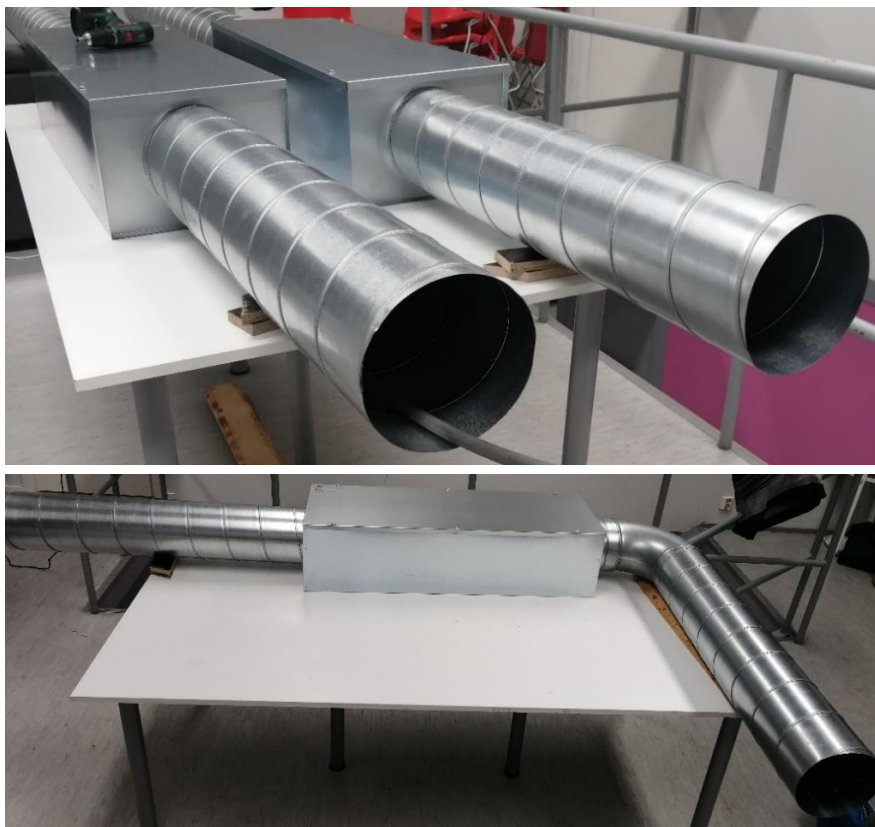
Figure 3. Installation situations in the examinations. In the top picture straight duct situation, in the bottom picture 90° elbow situation.

- Straight duct situation
 - 1 m of straight duct before the silencer
 - 2 m of straight duct after the silencer
- 90° elbow situation
 - 1 m of straight duct + 90° elbow right before the silencer
 - 2 m of straight duct after the silencer

Pictures of the installation positions are presented in figure 3.

Photographs of the installation situations can be seen in figure 3. All the tested situations are presented in table 2.

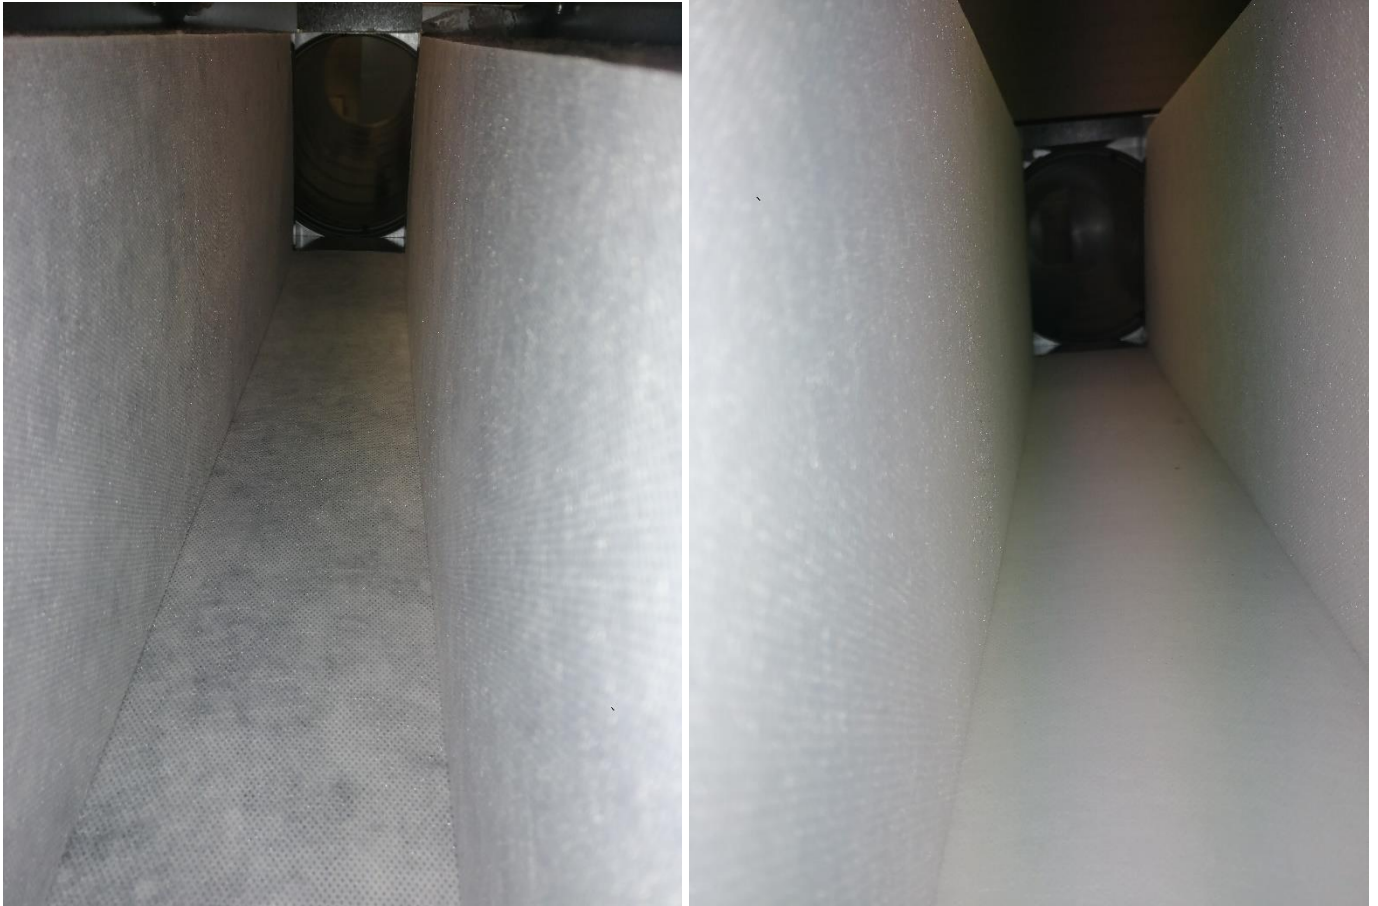
Figure 4. Straight installation: 1 brush cycle: KVDPX-2 no1 and KVDPX-4 no1.

Based on performed cleaning procedures and tests, it can be stated that no traces of the brushing could be perceived through sensory evaluation after 1 or 5 brushings. See figures 4–5 and 8–9. After 10 and 20 brushings, very light frizzing could be perceived on the lining of all the examined silencers, with the lining still being completely intact. See figures 6–7 and 10–11.

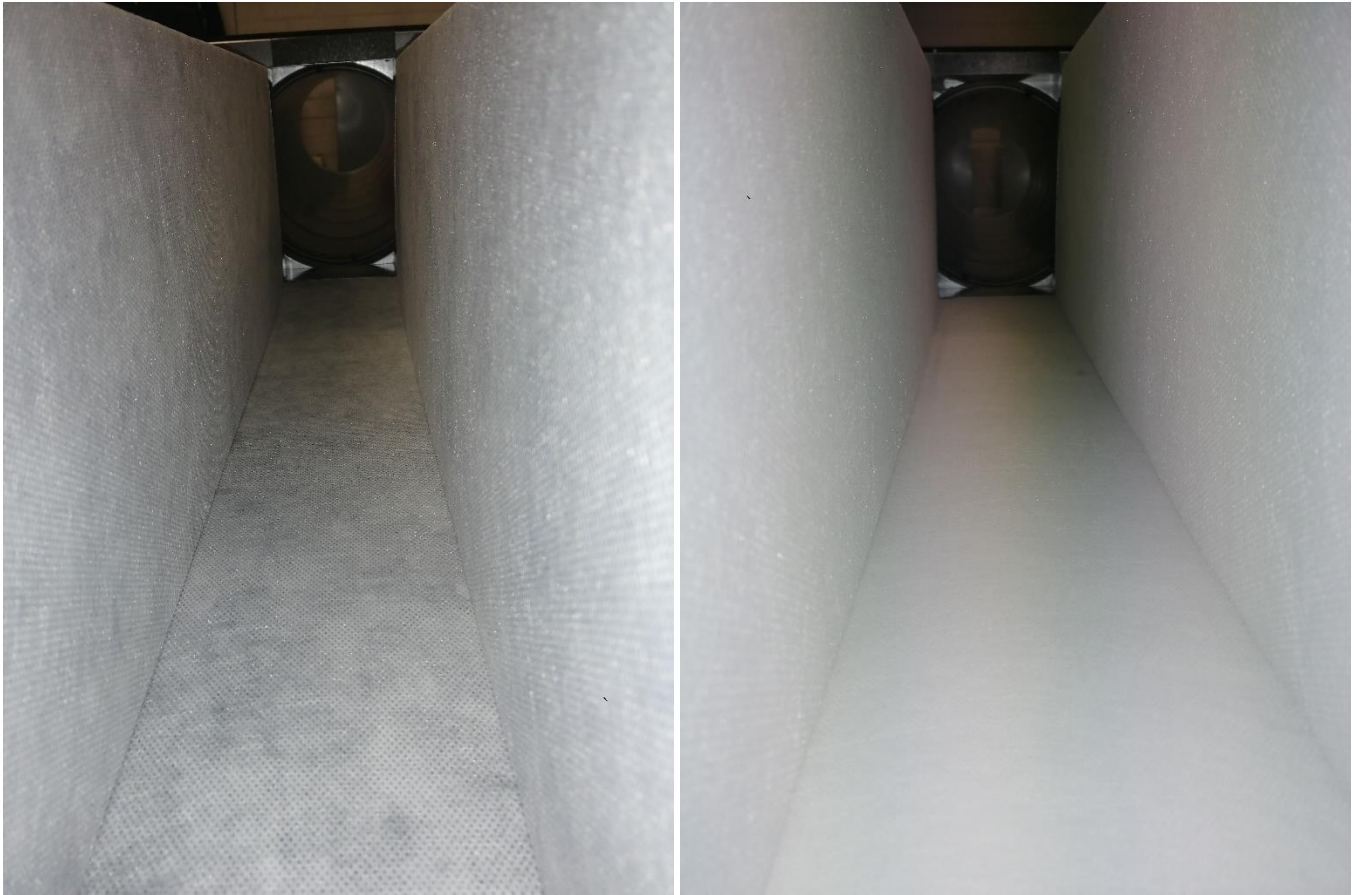
Figure 5. Straight installation: 5 brush cycles: KVDPX-2 no1 and KVDPX-4 no1.

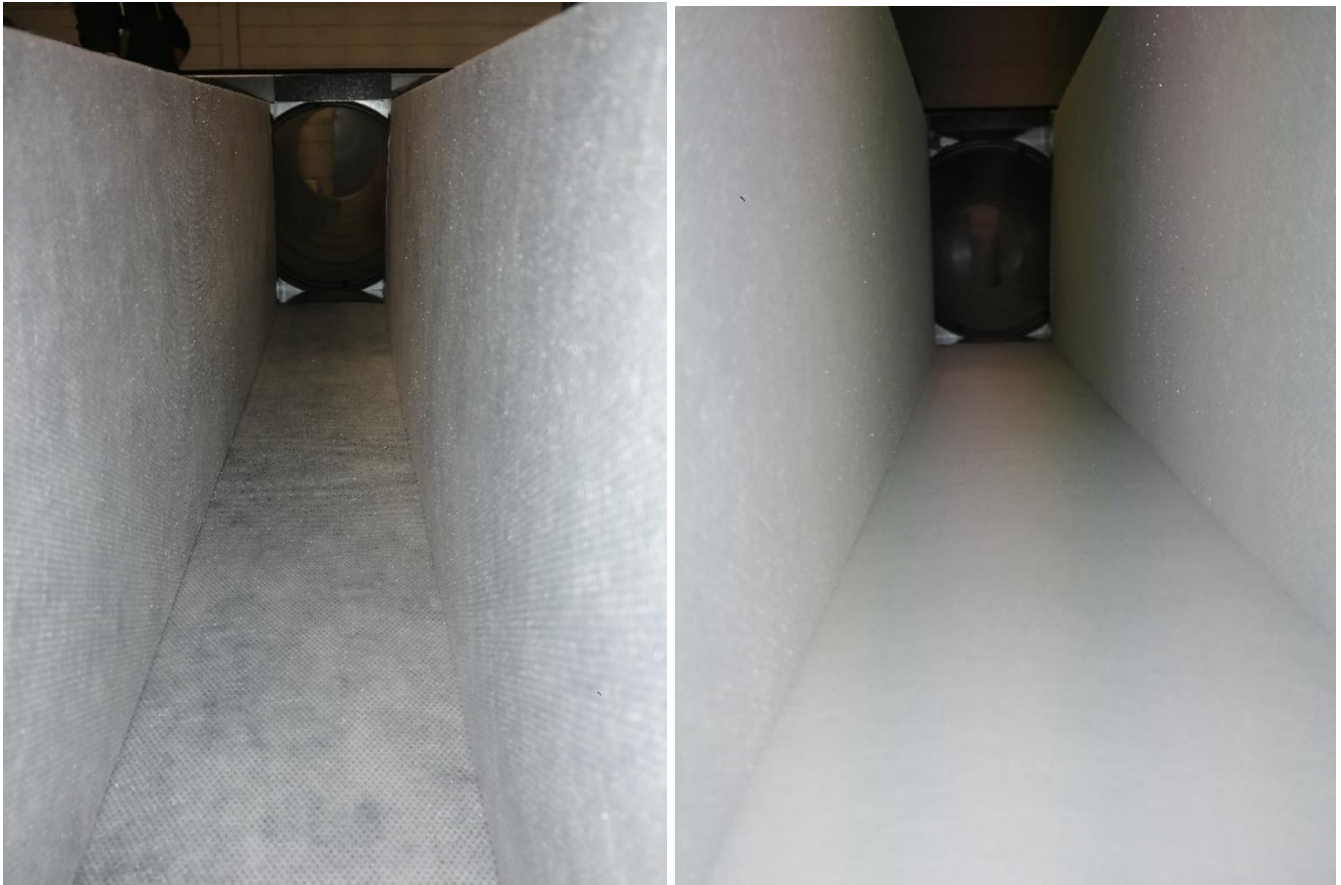
Figure 6. Straight installation: 10 brush cycles: KVDPX-2 no1 and KVDPX-4 no1.

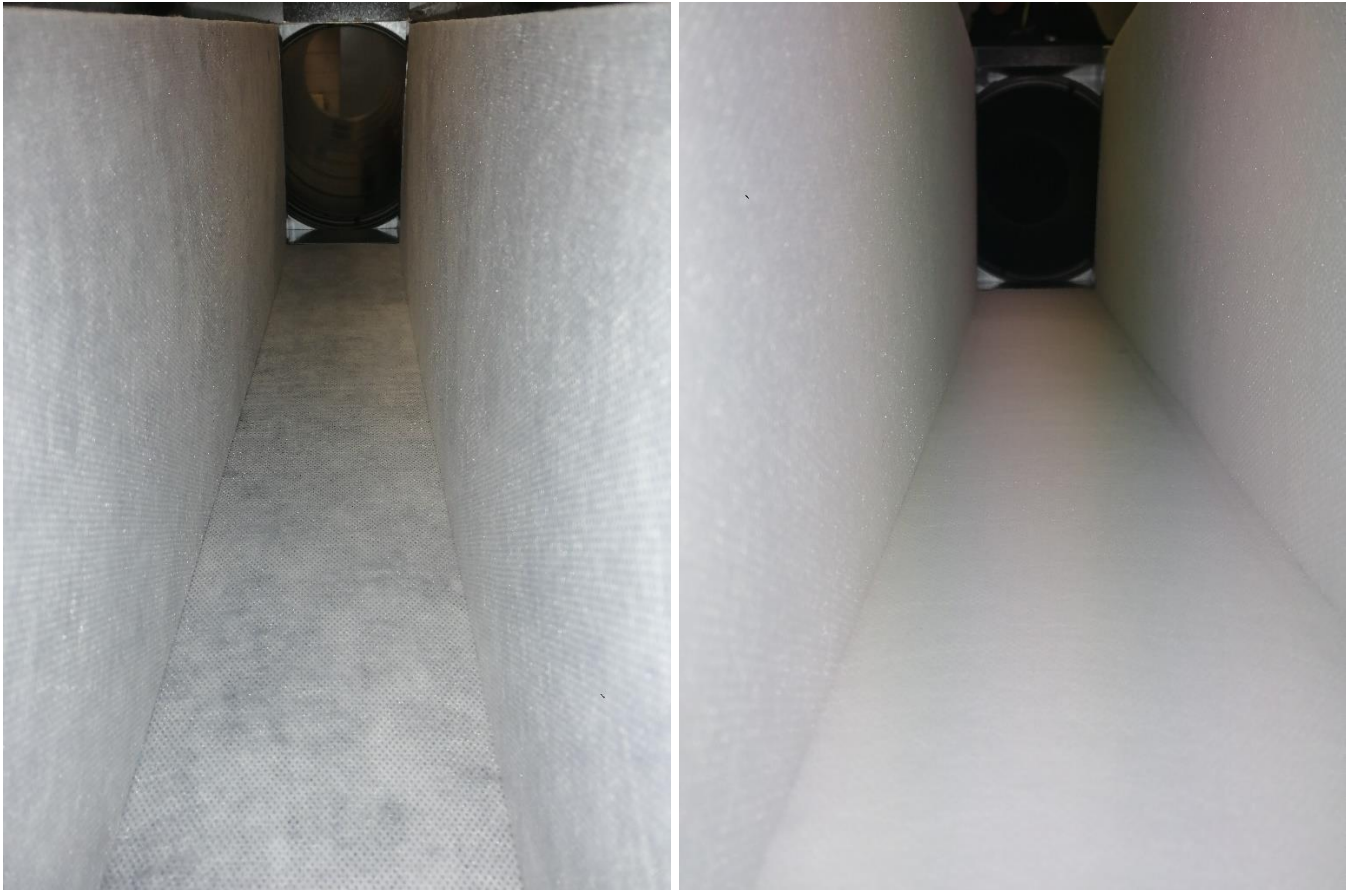
Figure 7. Straight installation: 20 brush cycles: KVDPX-2 no1 and KVDPX-4 no1.

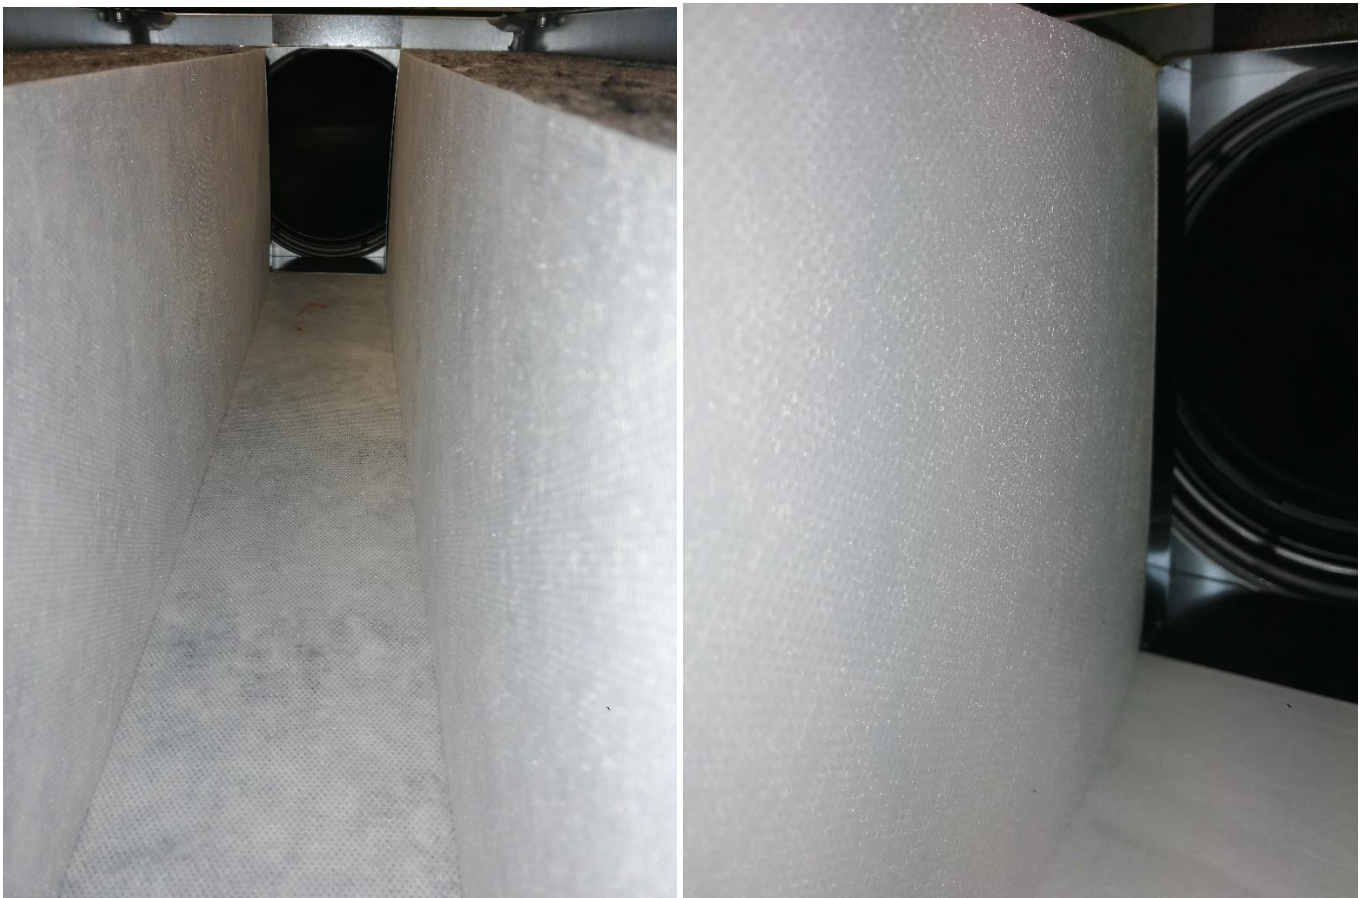
Figure 8. 90° elbow: 1 brush cycle: KVDPX-2 no2 and KVDPX-4 no2.

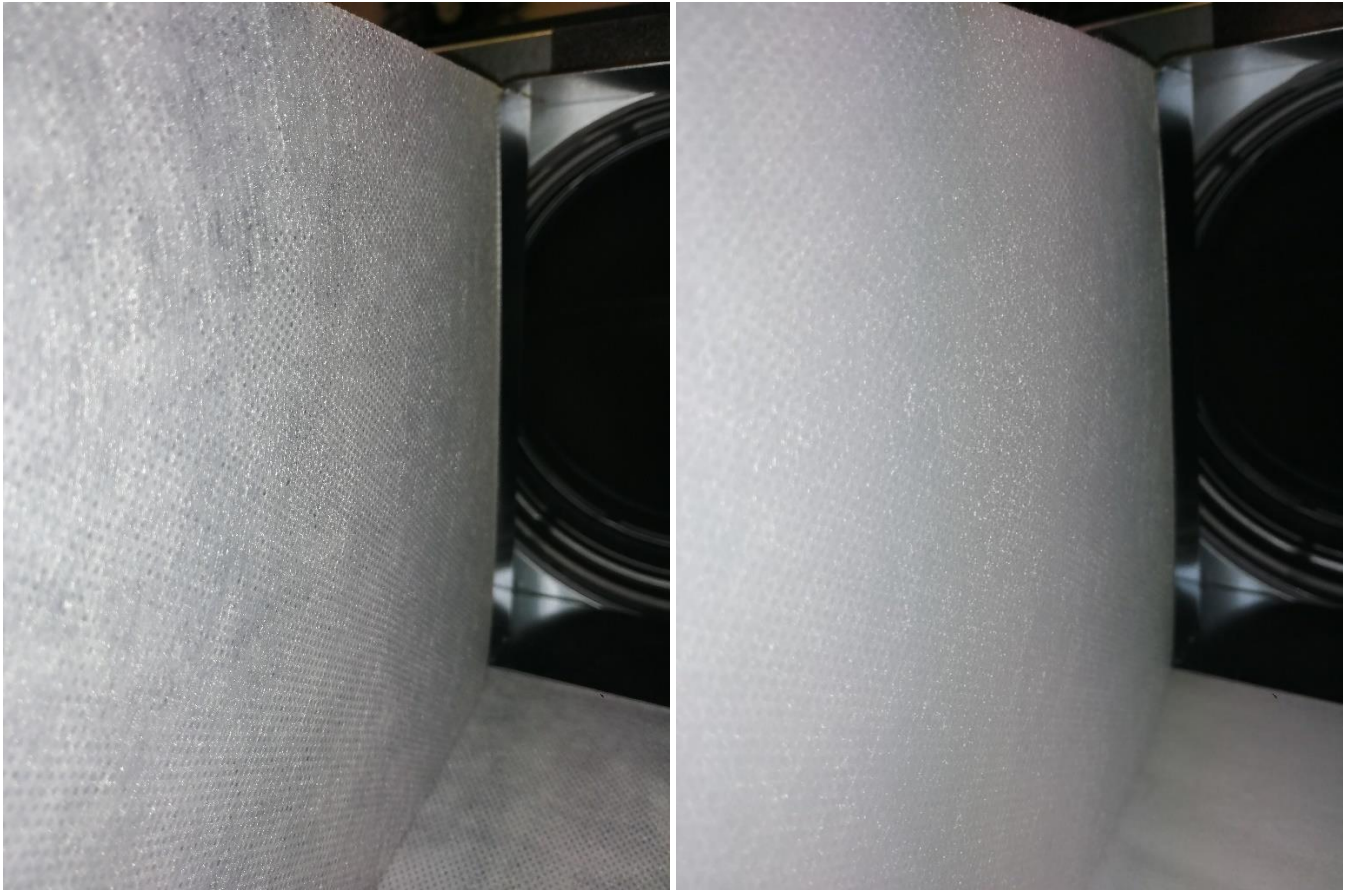
Figure 9. 90° elbow: 5 brush cycles: KVDPX-2 no2 and KVDPX-4 no2.

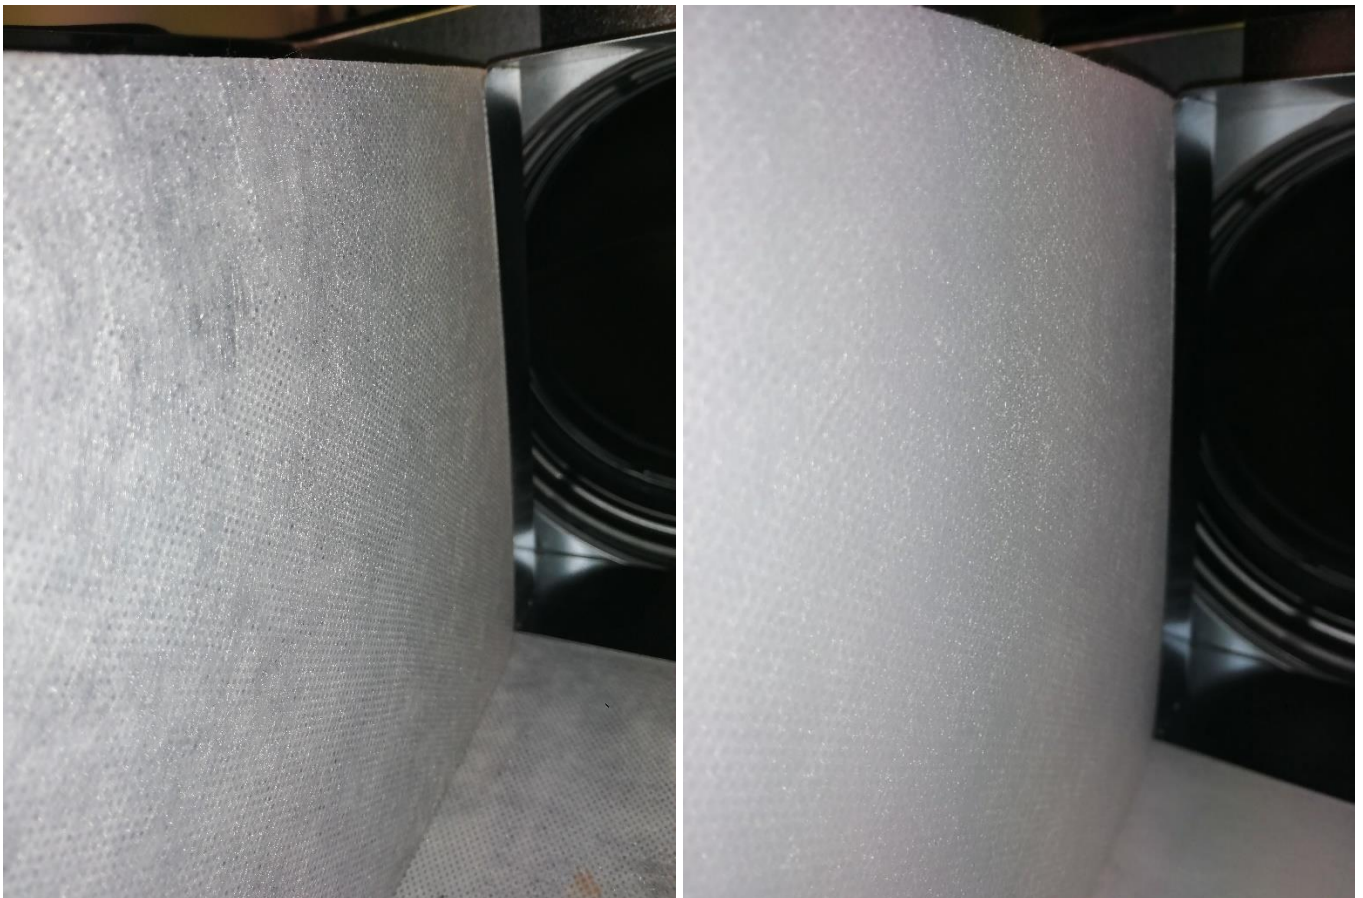
Figure 10. 90° elbow: 10 brush cycles: KVDPX-2 no2 and KVDPX-4 no2.

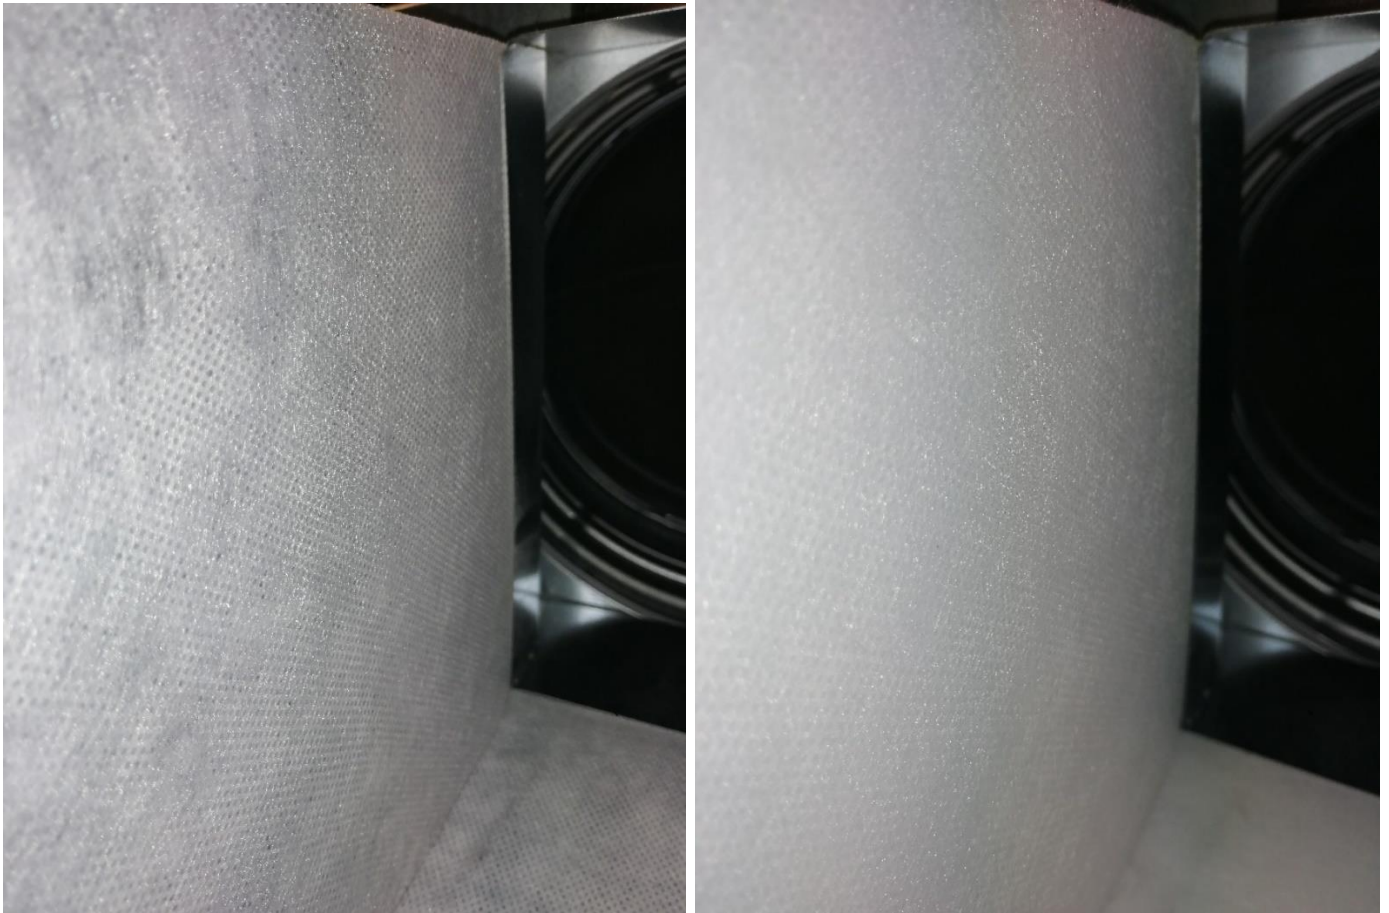
Figure 11. 90° elbow: 20 brush cycles: KVDPX-2 no2 and KVDPX-4 no2.

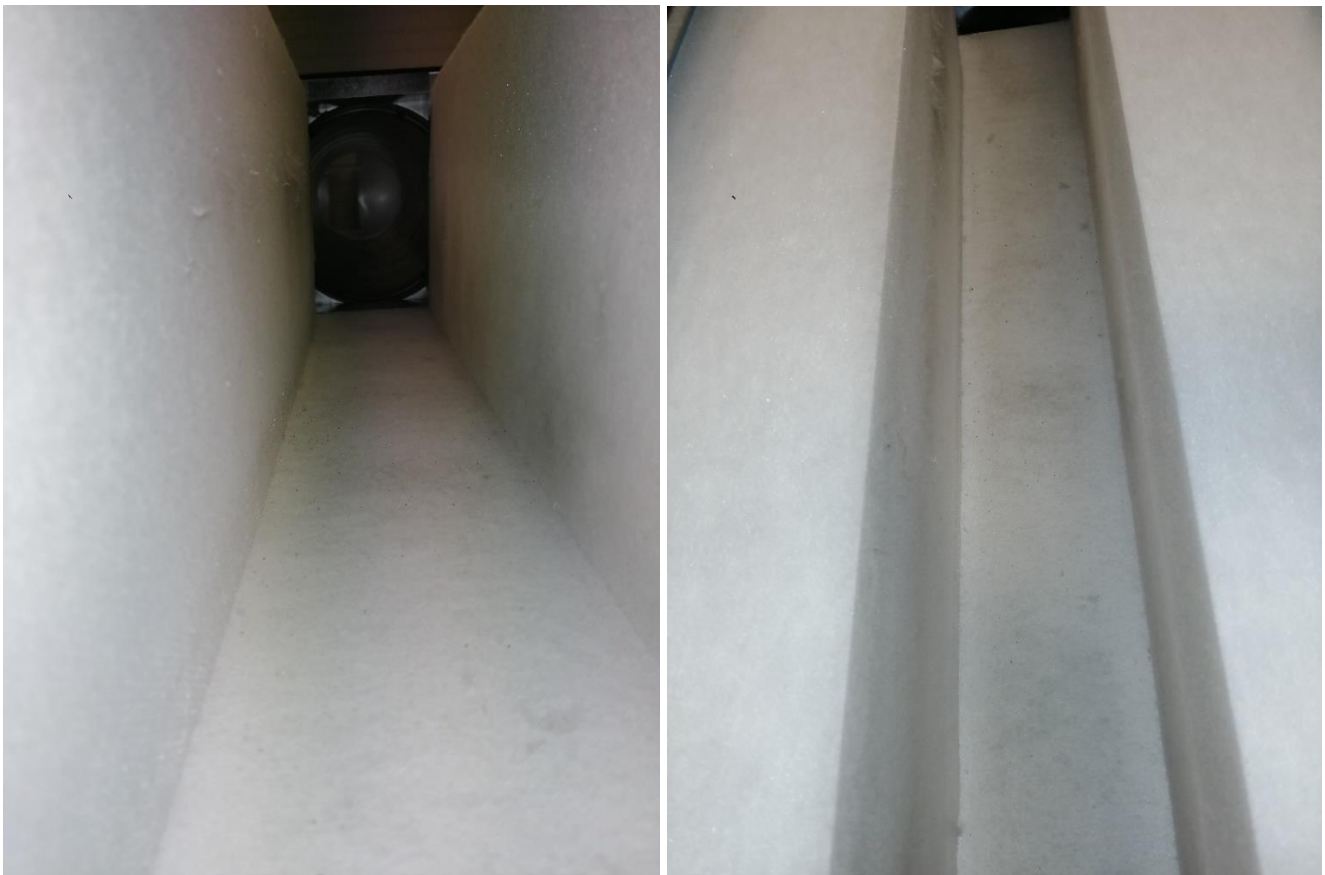
Figure 12. Straight duct: 1 brush cycle with steel brush: KVDPX-4 no1.

After the brushing performed with the steel brush, the lining of the silencer was damaged/teared at several positions. Additionally, abrasion of the lining was perceived throughout the silencer. See figure 12.

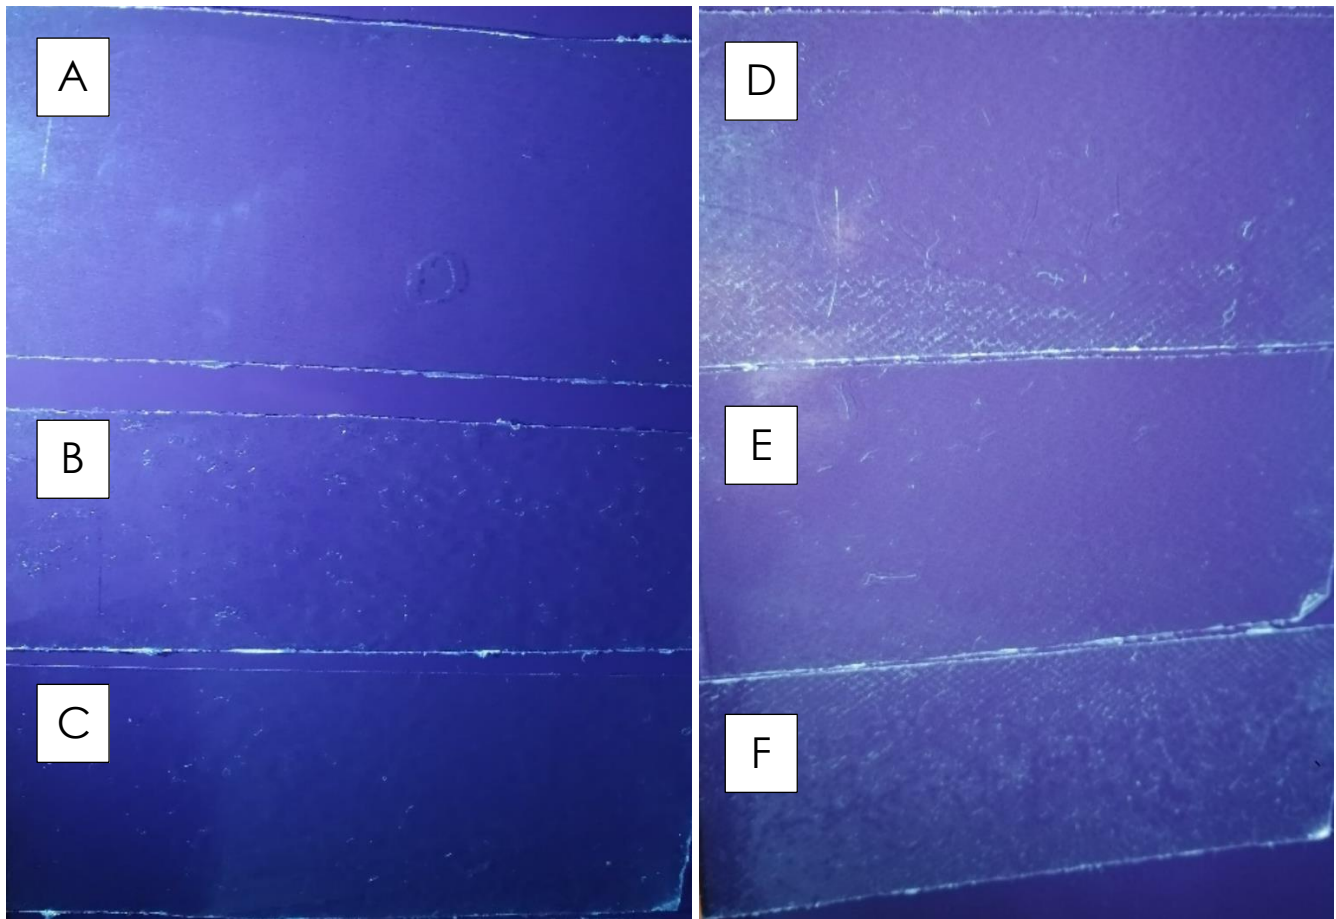
Figure 13. Silencer KVDPX-2 no 1 (straight duct): unused adhesive tape (A), 0 (B), 1 (C), 5 (D), 10 (E) and 20 (F) brush cycles.

Based on samples taken by means of adhesive tape, the amount of detached particles/fibers caused by the brushing is very small and is slightly increased with increasing brush cycles. See figures 13–16.

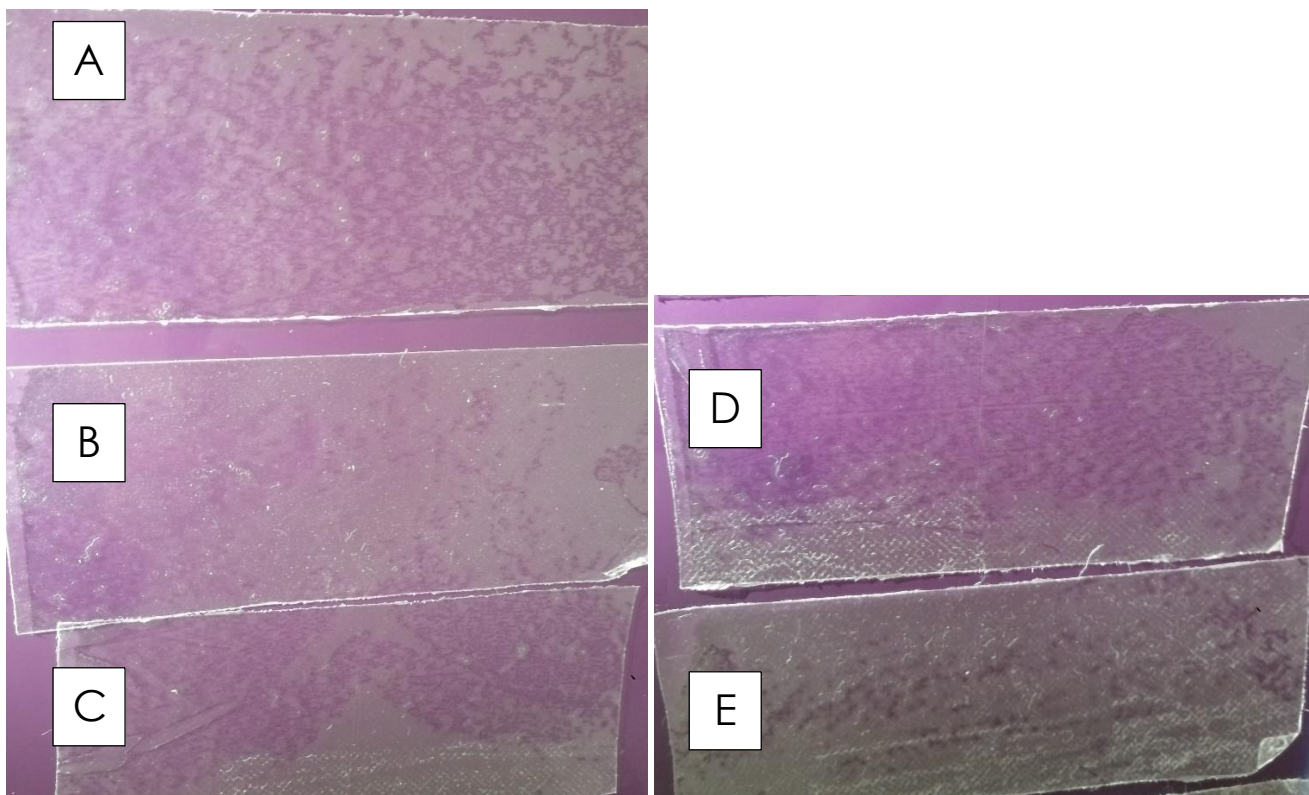
Figure 14. Silencer KVDPX-4 no 1 (straight duct): 0 (A), 1 (B), 5 (C), 10 (D) and 20 (E) brush cycles.

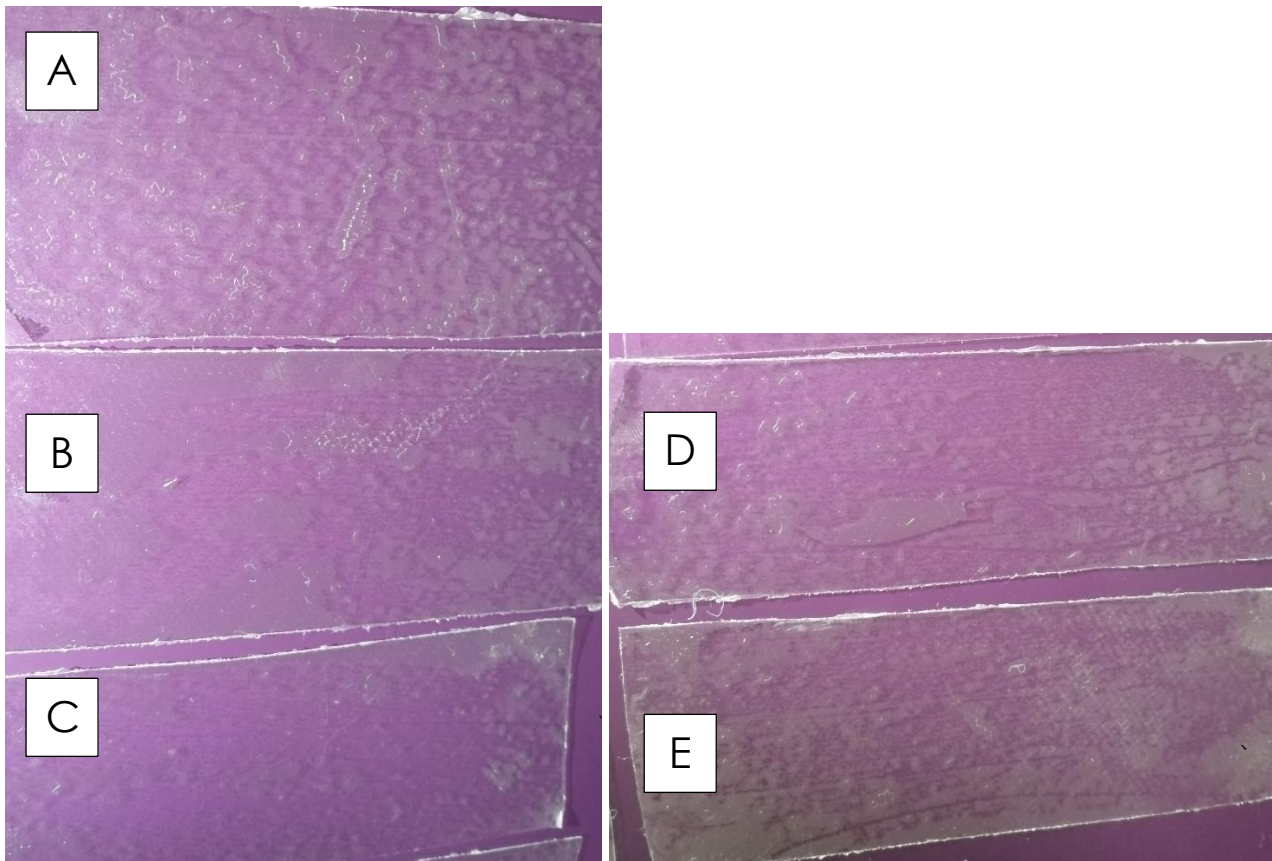
Figure 15. Silencer KVDPX-2 no 2 (90° elbow):
0 (A), 1 (B), 5 (C), 10 (D) and 20 (E) brush cycles.

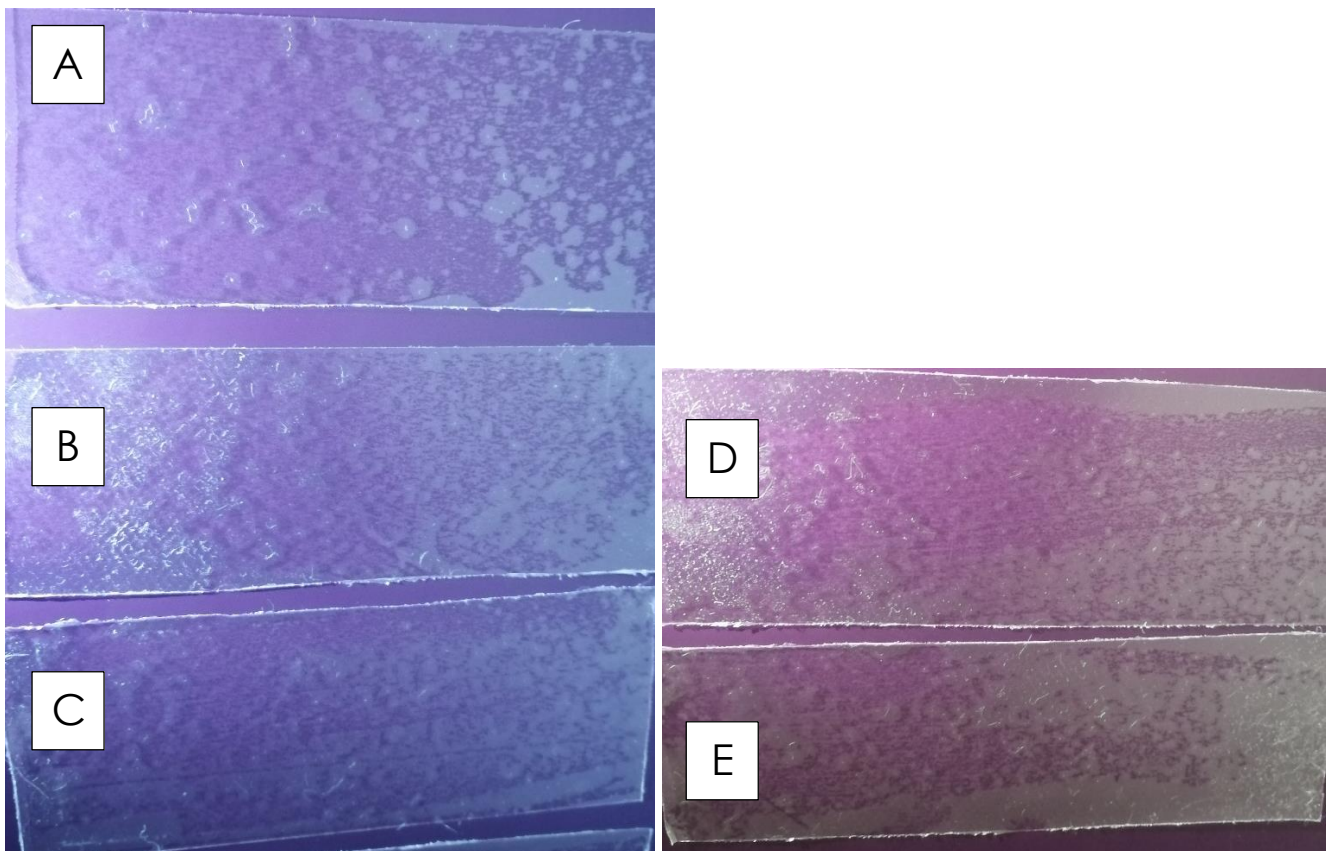
Figure 16. Silencer KVDPX-4 no 2 (90° elbow):
0 (A), 1 (B), 5 (C), 10 (D) and 20 (E) brush cycles.

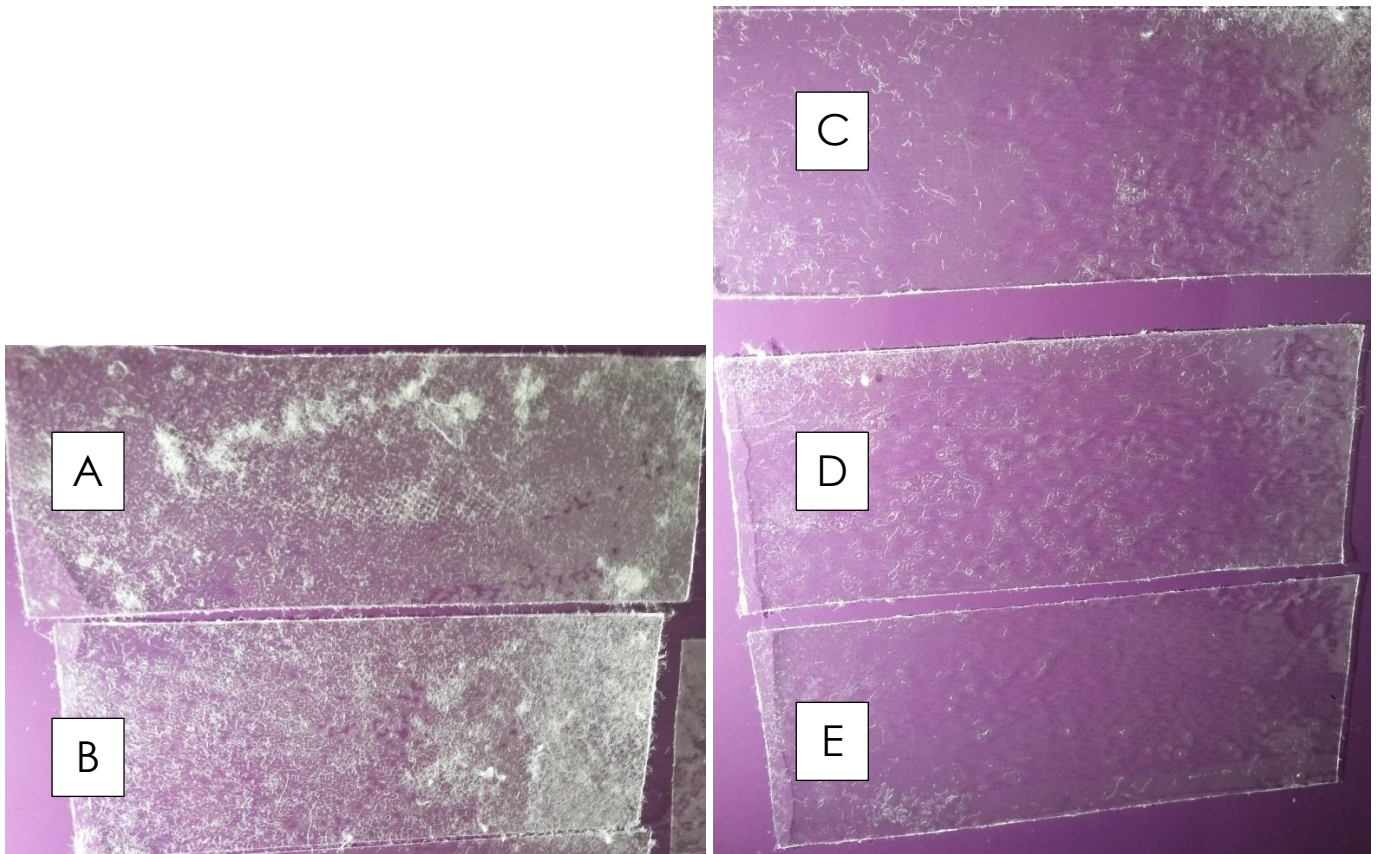
Figure 17. Silencer KVDPX-4 no 1 (straight duct – steel brush):
 1 brush cycle with steel brush (A), 4 consecutive adhesive tape samples from same position (B, C, D and E).

Adhesive tape samples were also taken repeatedly from the same positions from two silencers to investigate whether the particles/fibers are continuously detaching. Based on the samples, it can be stated that particles/fibers will not detach continuously after brushing, meaning that the material has not started "leaking". The same result could also be perceived in the silencer cleaned with the steel brush, even though the lining was partially damaged. See figures 17 and 18.

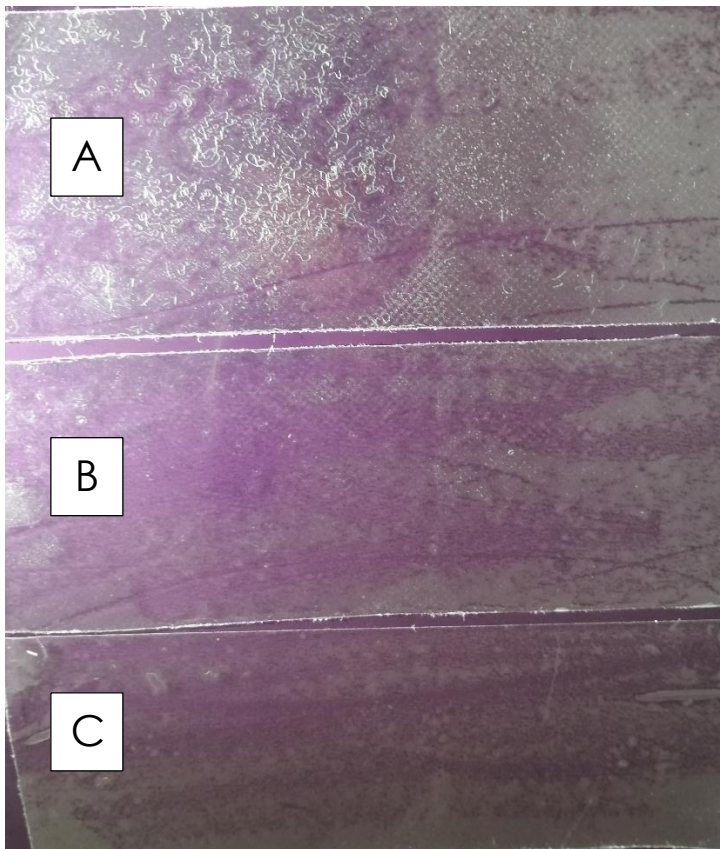
Figure 18. Silencer KVDPX-4 no 2 (90° elbow):
 3 consecutive adhesive tape samples after 20 brush cycles (A, B and C).
